Manhole Inspection Summary

Manhole # S07CC2007MH

Insp Date: **8/8/06 10:37 AM**

Location Address: **6002 BERKELEY AVE**

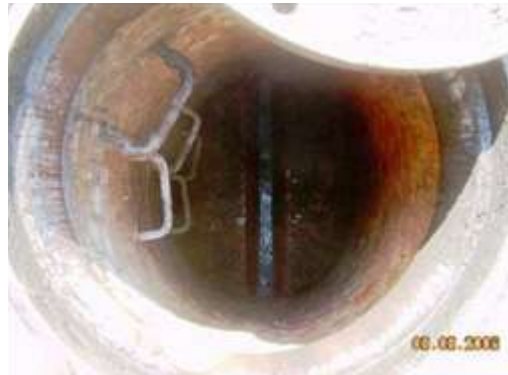
Top View

Adjustment and Barrel infiltration. Bench debris. Corroded steps.

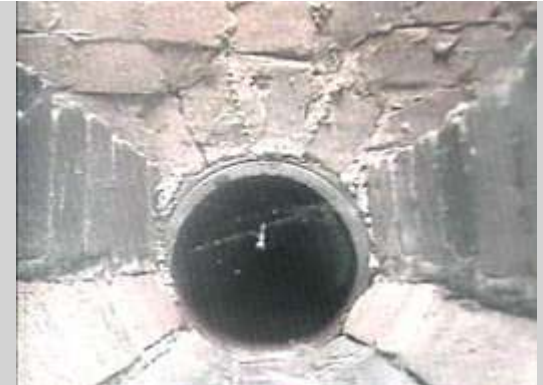
8 in. Circular Gravity Sewer Pipe Out @ 12 O'Clock

Barrel deterioration and infiltration. Channel deterioration.

Infiltration: **Evidence** Pipe Seal Cond: **Unknown**

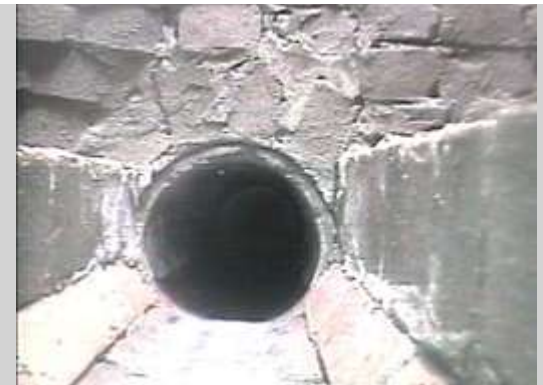
8 in. Circular Gravity Sewer Pipe In @ 6 O'Clock

Barrel deterioration and infiltration. Channel deterioration.

Infiltration: **Evidence** Pipe Seal Cond: **Unknown**
